Phase I Inspection Report
Mongaup Falls Dam
Delaware River Basin, Sullivan County, New York
Inventory No. 321

5. TYPE OF REPORT & PERIOD COVERED
Phase I Inspection Report
National Dam Safety Program

PHASE I INSPECTION REPORT
NATIONAL DAM SAFETY PROGRAM
MONGAUP FALLS DAM, I.D. NO. NY 321
DEC #148D-130
DELAWARE RIVER BASIN
SULLIVAN COUNTY, NEW YORK

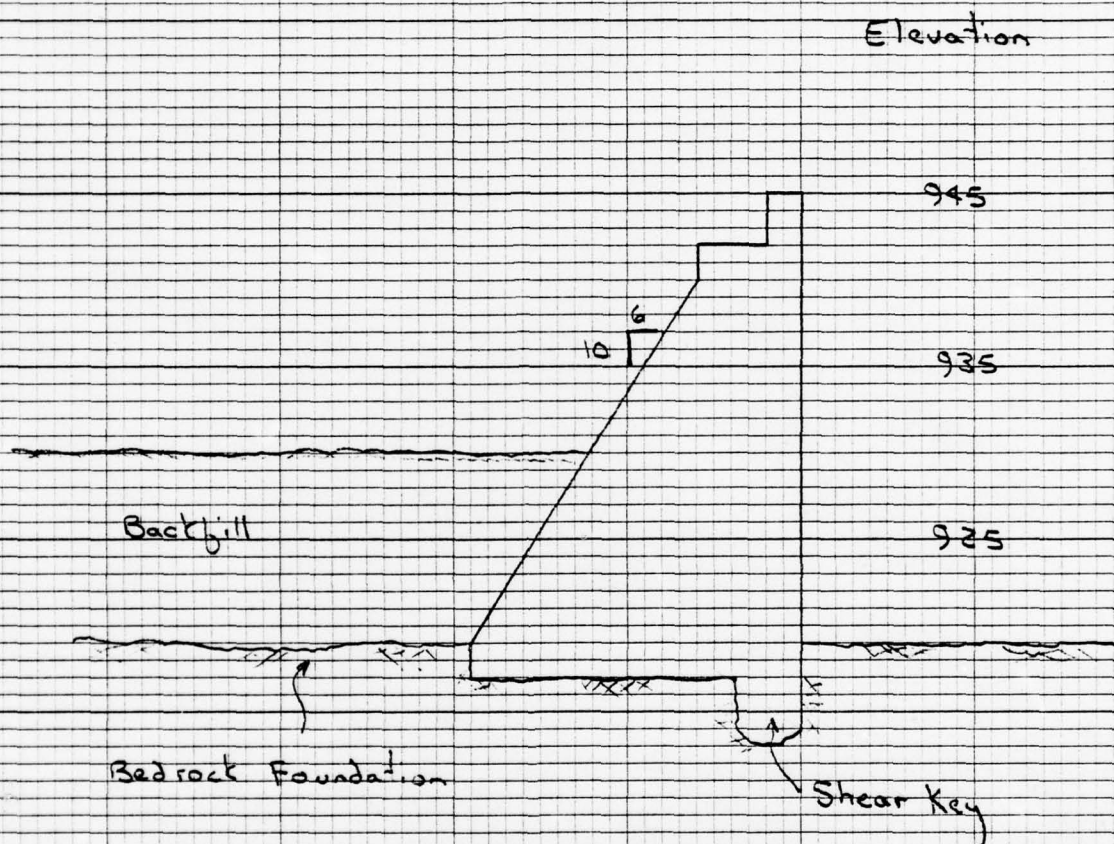
Mongaup Falls Dam Non-Overflow Section

NOTE: A shear key located at the heel of the dam contributes to the sliding resistance of the dam. The stability analysis does not include this option. Therefore, the additional calculations below the computed factors of safety are shown to account for the benefit of the shear key.

middle $\frac{1}{3}$ of base ranges
from 6.3' to 12.7'

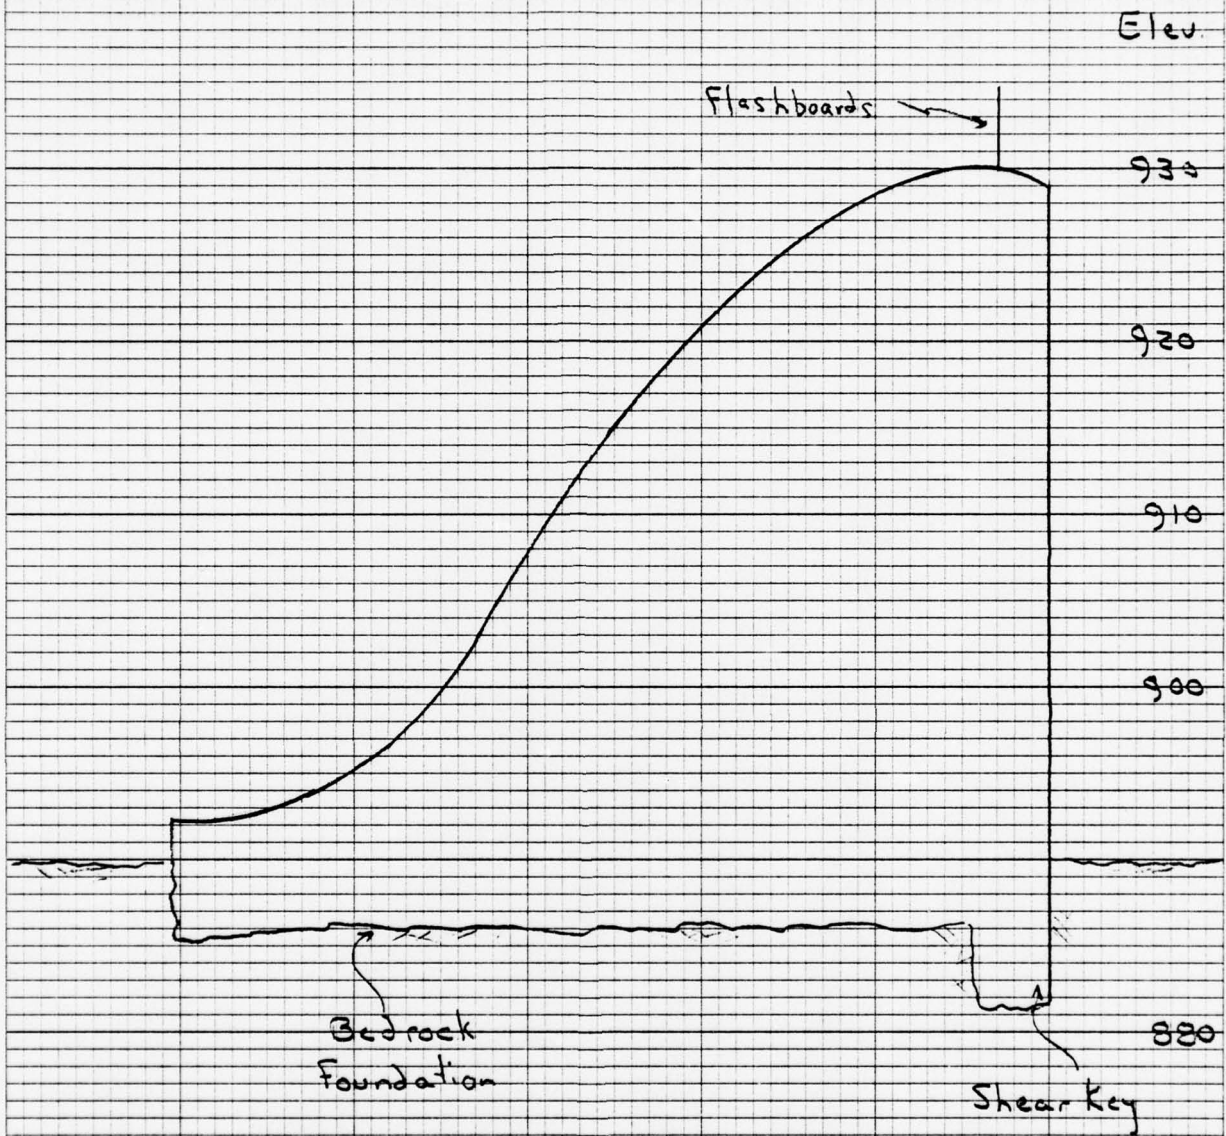
Mongaup Falls Dam Spillway Section

middle $\frac{1}{3}$ of base ranges
from 16.7' to 33.9'
